**Phase I Environmental Site  
Assessment Report**

71 Auto Center Drive and  
Adjacent Parcel (APN 612-161-11)  
Foothill Ranch, California

May 20, 2011

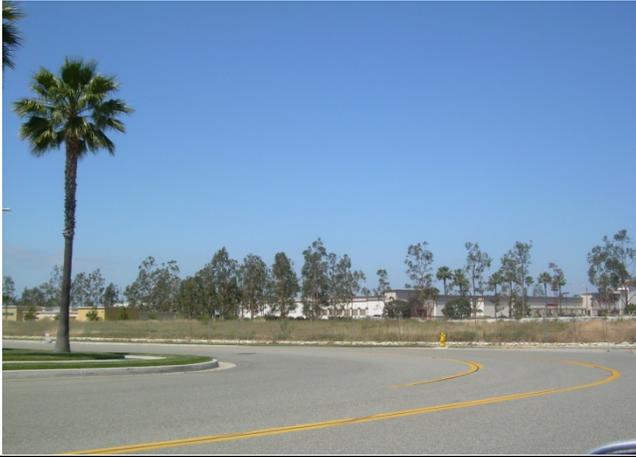
1. View of the south Site parcel facing southwest.

The southern Site parcel is approximately 4.2-acres of undeveloped land. The Site was covered in soil and native vegetation including grass. No environmental hazards, such as the disposal of hazardous materials, were observed during the Site inspection.

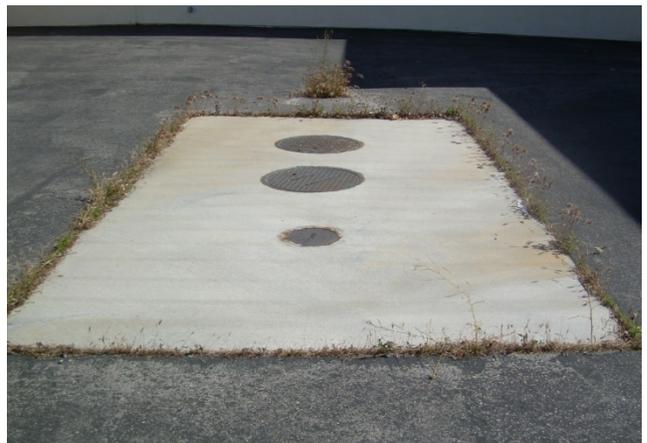
12. View of a three-stage clarifier located on the southwest side of the Site.

bay. No staining was observed around or in the drains. These drains are connected to a three-stage subsurface clarifier located on the southwest side of the building. Reportedly the clarifier was installed in 2005 and only used for approximately a year and a half. Based on the relatively short duration of use, the presence of the clarifier is not expected to represent an environmental concern to the Site. However, if the Site is redeveloped, the clarifier should be removed in accordance with regulatory guidelines.

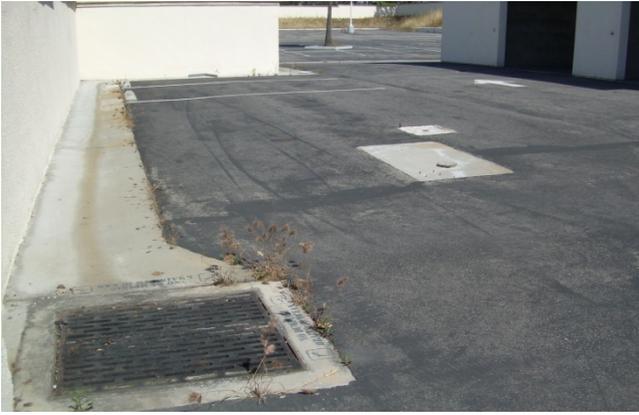
13. View of a typical storm drain located throughout the parking area of the Site.

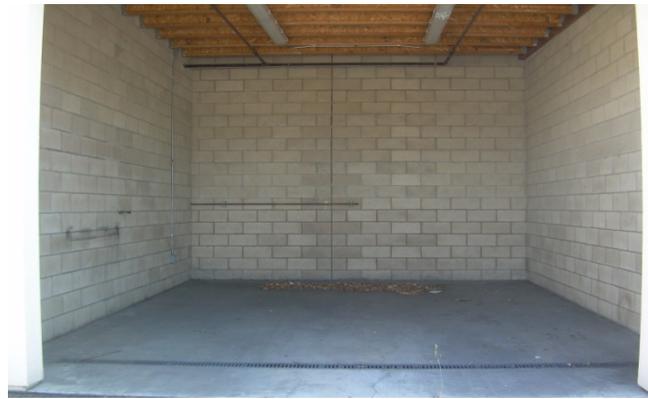
14. View of former carwash bay at the Site.

The exterior portions of the Site consist of asphalt-paved parking areas and landscaping. ARCADIS observed several carwash bays located on the southwest portion of the Site building. ARCADIS observed a ribbon drain within each carwash

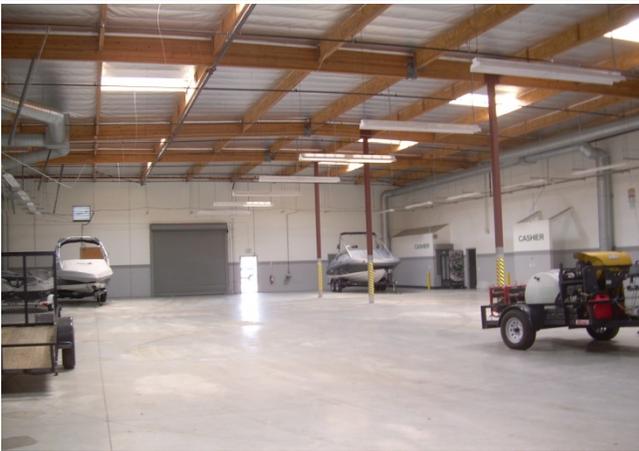
15. View inside the service area of the Site building.

The northern Site parcel is approximately 4.5-acres and is improved with a single-story commercial building with mezzanine totaling approximately 25,500 square-feet. The Site building is currently vacant. The Site building consists of an office and showroom area and former service center. ARCADIS observed several boats, trailers and miscellaneous supplies stored within the service center. In addition, ARCADIS observed several patched areas on the concrete surface of the service area which are the location of the former hydraulic lifts. No staining was visible around the former lifts and the concrete floor throughout the service center appeared to be in good condition.

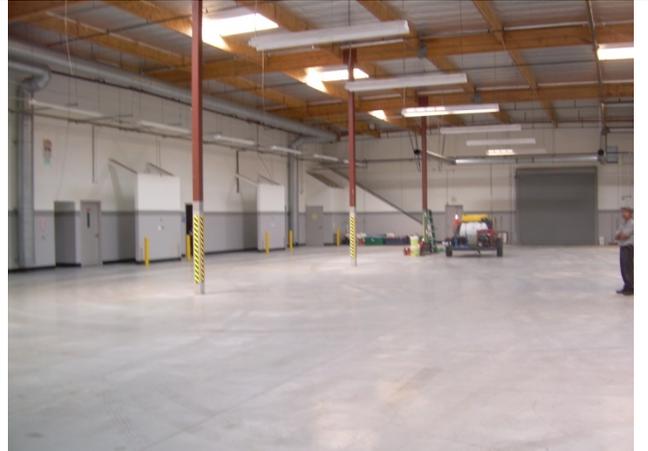
16. Another View inside the service area of the Site building.

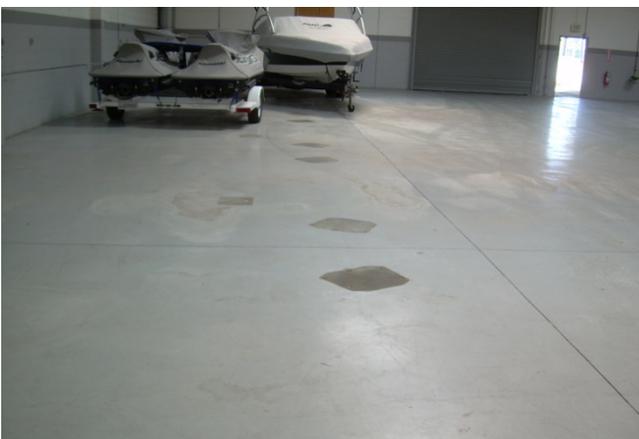
17. View of the location of the former hydraulic lifts.

AEI also noted the presence of eight aboveground hydraulic lifts located in the service area. The equipment was only used for approximately a year and a half and no signs of staining were noted in the vicinity of the lifts. AEI stated that based on the small quantity of hydraulic fluid used in connection with the operation of this equipment, the lifts were not expected to represent a significant concern to the Site. During ARCADIS's inspection, the lifts had been removed and the concrete surface in the area of the former lifts appeared to be in good condition. Therefore, ARCADIS concurs with AEI that the former lifts do not represent an environmental concern to the Site.
