BMP INSPECTION & MAINTENANCE RESPONSIBILITY MATRIX			
BMP Applicable? Yes/No	BMP Name and BMP Implementation, Maintenance and Inspection Procedures	Implementation, Maintenance, and Inspection Frequency and Schedule	Person or Entity with Operation & Maintenance Responsibility
No	N9. Hazardous Materials Disclosure Compliance	Not Applicable	
No	N10. Uniform Fire Code Implementation	Not Applicable	
Yes	N11. Common Area Litter Control The HOA will be responsible for performing trash pickup and sweeping of littered common areas on a weekly basis or whenever necessary. Responsibilities will also include noting improper disposal materials by homeowners and reporting such violations to the HOA for investigation.	Litter patrol, violations investigation, reporting and other litter control activities shall be performed weekly and in conjunction with maintenance activities. <u>Frequency:</u> Weekly	Brookfield Residential / HOA

Filterra® Stormwater Bioretention
Filtration Systems

Subject: Infiltration Design Rate, Tentative Tract 17446, "Town Centre", Lake Forest, California

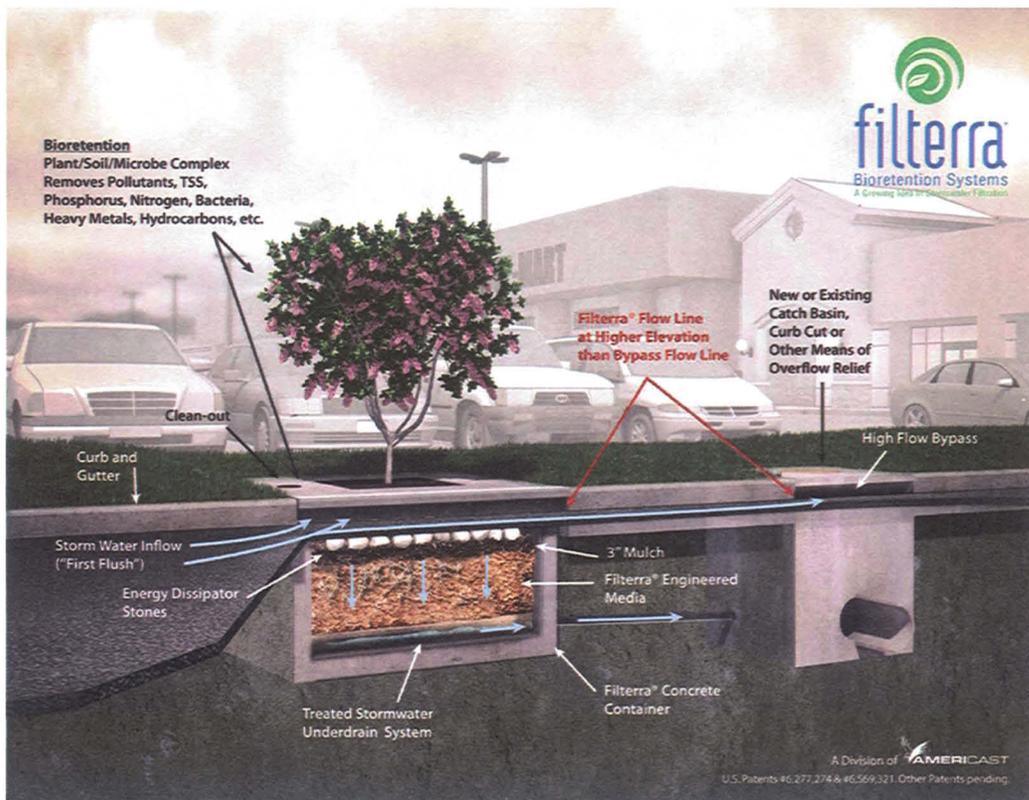
General Description

The following general specifications describe the general operations and maintenance requirements for the Americast stormwater bioretention filtration system, the Filterra®. The system utilizes physical, chemical and biological mechanisms of a soil, plant and microbe complex to remove pollutants typically found in urban stormwater runoff. The treatment system is a fully equipped, pre-constructed drop-in place unit designed for applications in the urban landscape to treat contaminated runoff.

Stormwater flows through a specially designed filter media mixture contained in a landscaped concrete container. The mixture immobilizes pollutants which are then decomposed, volatilized and incorporated into the biomass of the Filterra® system's micro/macro fauna and flora. Stormwater runoff flows through the media and into an underdrain system at the bottom of the container, where the treated water is discharged. Higher flows bypass the Filterra® to a downstream inlet or outfall.

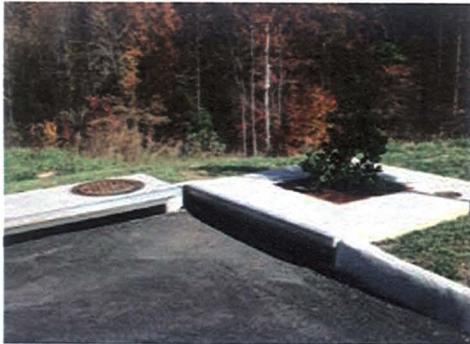
1. Inspection of Filterra® and surrounding area

- Record individual unit **before** maintenance with photograph (numbered). Record on Maintenance Report (see example in this document) the following:

Standing Water	yes no
Damage to Box Structure	yes no
Damage to Grate	yes no
Is Bypass Clear	yes no

If yes answered to any of these observations, record with close-up photograph (numbered).

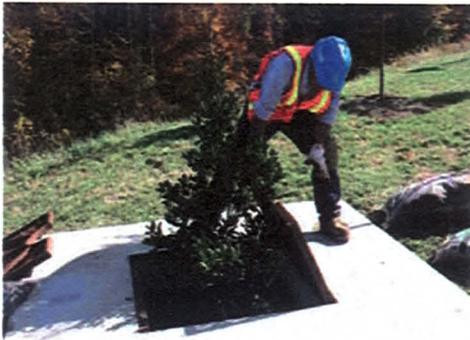
2. Removal of tree grate and erosion control stones

- Remove metal grates for access into Filterra® box.
- Dig out silt (if any) and mulch and remove trash & foreign items.

Silt/Clay	yes no
Cups/ Bags	yes no
Leaves	yes no
# of Buckets Removed

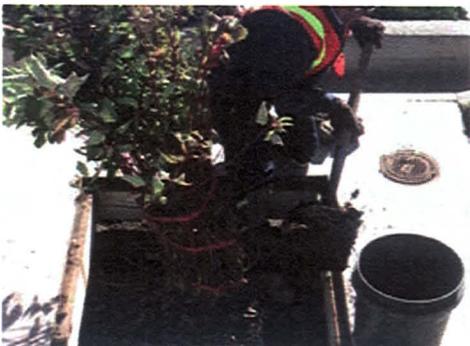
3. Removal of debris, trash and mulch

- After removal of mulch and debris, measure distance from the top of the Filterra® engineered media soil to the bottom of the top slab. If this distance is greater than 12", add Filterra® media (not top soil or other) to recharge to a 9" distance.

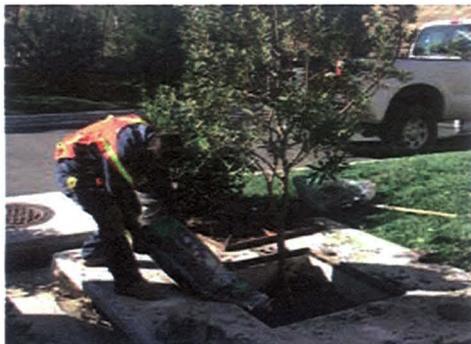
4. Mulch replacement

- Please see mulch specifications.
- Add double shredded mulch evenly across the entire unit to a depth of 3".
- Ensure correct repositioning of erosion control stones by the Filterra® inlet to allow for entry of trash during a storm event.
- Replace Filterra® grates correctly using appropriate lifting or moving tools, taking care not to damage the plant.

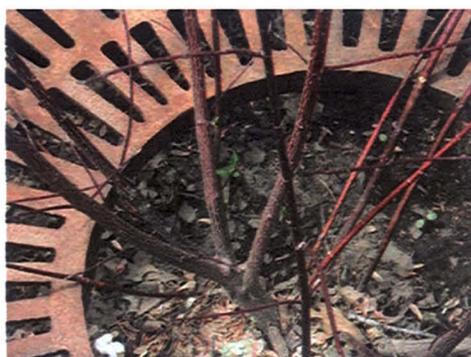
5. Plant health evaluation and pruning or replacement as necessary

- Examine the plant's health and replace if dead.
- Prune as necessary to encourage growth in the correct directions

Height above Grate	(feet)
Width at Widest Point	(feet)
Health	alive dead
Damage to Plant	yes no
Plant Replaced	yes no

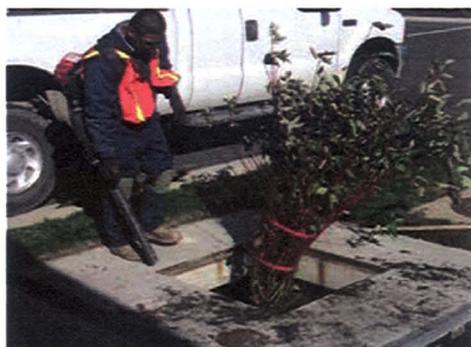
6. Clean area around Filterra®

- Clean area around unit and remove all refuse to be disposed of appropriately.

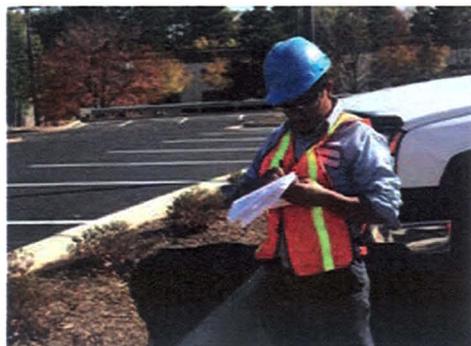
7. Complete paperwork

- Deliver Maintenance Report and photographs to appropriate location (normally Americast during maintenance contract period).
- Some jurisdictions may require submission of maintenance reports in accordance with approvals. It is the responsibility of the Owner to comply with local regulations.

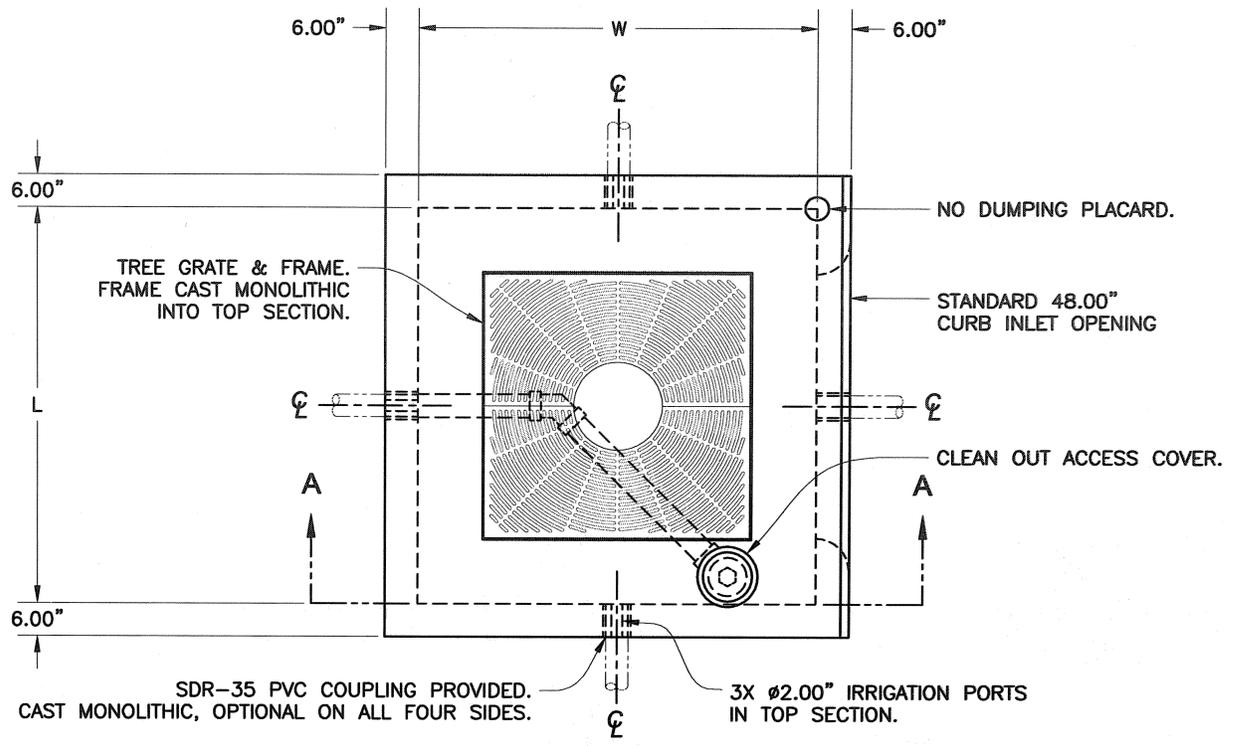
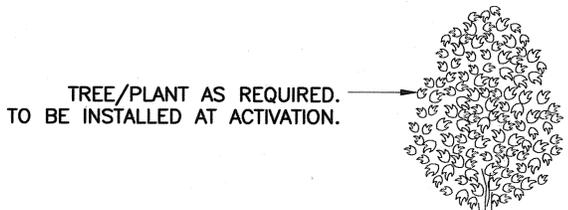
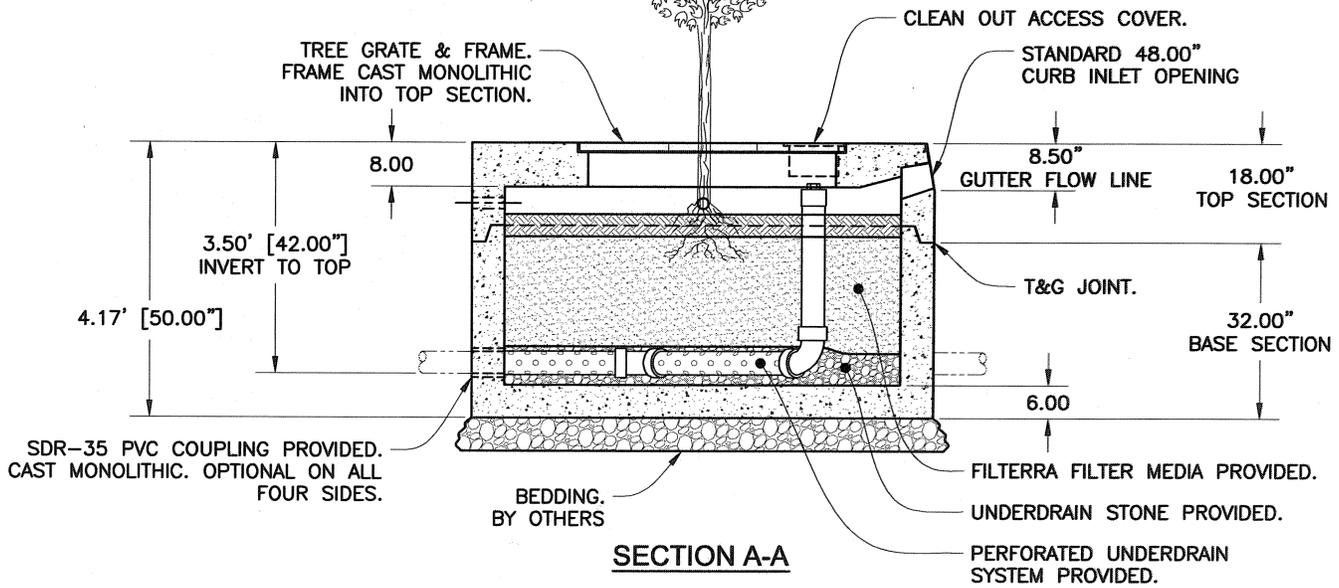
Precast Filterra® Unit
Standard Configuration (Square)
Western Zone

TABULATION					
Size / Designation	L (Feet)	W (Feet)	Tree Grate Quantity / Size	Outlet Pipe PVC SDR-35	
4' x 4'	4.00'	4.00'	1Ea. / 3' x 3'	Ø4.00"	
6' x 6'	6.00'	6.00'	1Ea. / 3' x 3'	Ø4.00"

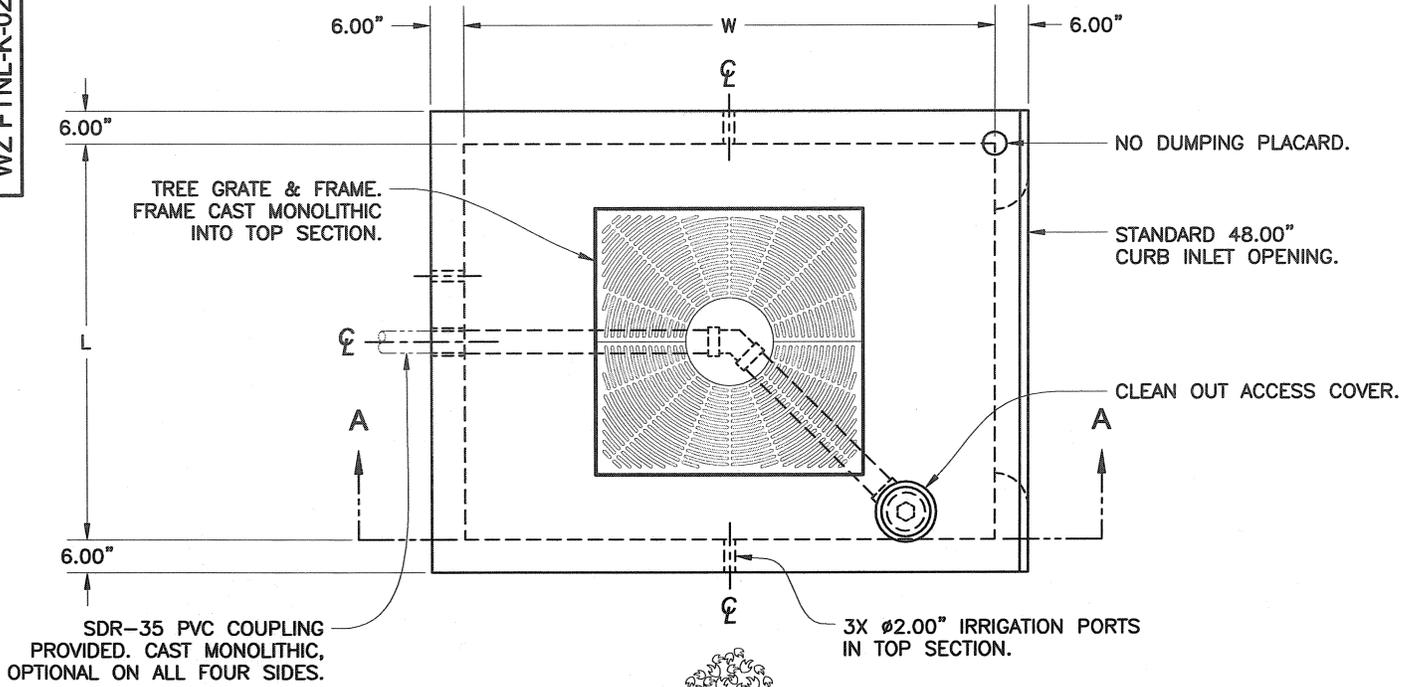
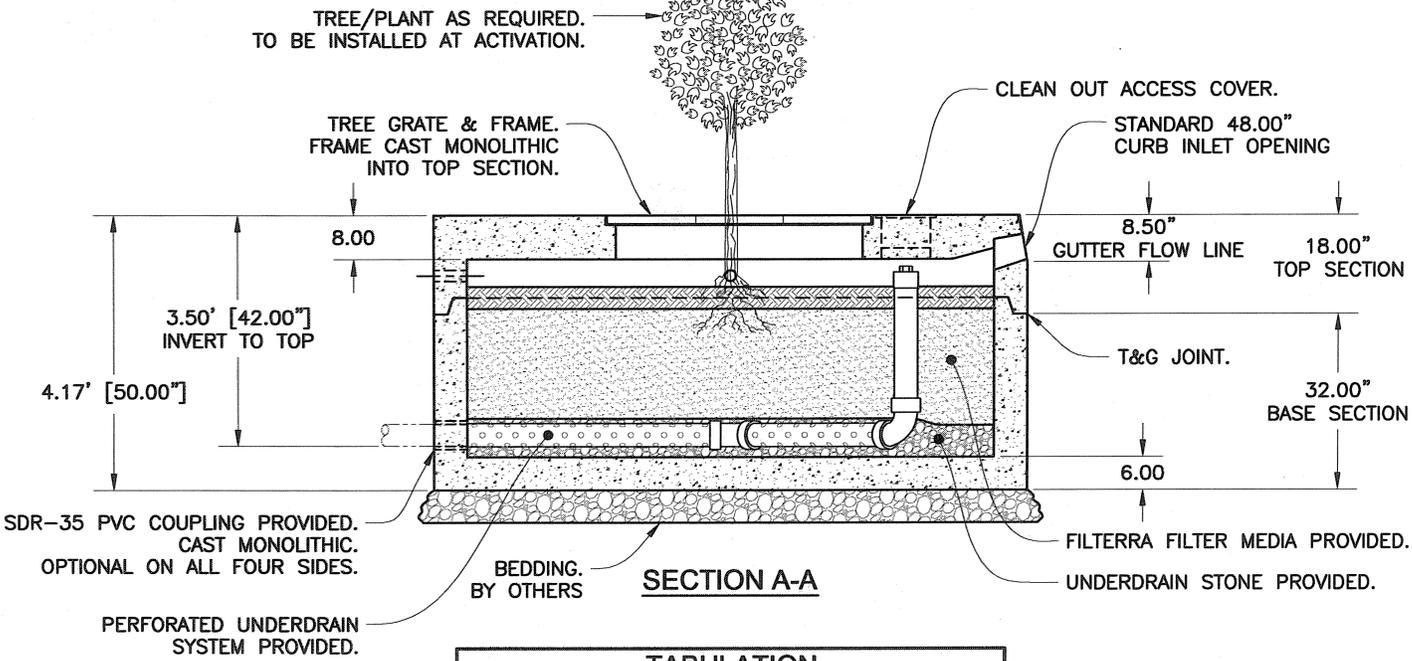
WZ FTNL-K-02

TABULATION				
Size / Designation	L (Feet)	W (Feet)	Tree Grate Quantity / Size	Outlet Pipe PVC SDR-35
4' X 6'	4.00'	6.00'	1ea. / 3' x 3'	Ø4.00"
4' x 6.5'	4.00'	6.50'	1ea. / 3' x 3'	Ø4.00"
4' x 8'	4.00'	8.00'	1ea. / 3' x 3'	Ø4.00"
4' x 16'	4.00'	16.00'	2ea. / 3' x 3'	Ø4.00"
6' x 8'	6.00'	8.00'	1ea. / 4' x 4'	Ø4.00"
6' x 10'	6.00'	10.00'	1ea. / 4' x 4'	Ø6.00"
6' x 12'	6.00'	12.00'	2ea. / 4' x 4'	Ø6.00"
8' x 16'	8.00'	16.00'	2ea. / 4' x 4'	Ø6.00"
8' x 18'	8.00'	18.00'	3ea. / 4' x 4'	Ø6.00"
8' x 20'	8.00'	20.00'	3ea. / 4' x 4'	Ø6.00"
