# **GEOTECHNICAL INVESTIGATION**

**PORTOLA CENTER SOUTH  
TENTATIVE TRACT NO. 15353  
LAKE FOREST, CALIFORNIA**

**JULY 6, 2012  
PROJECT NO. G1218-52-01A**

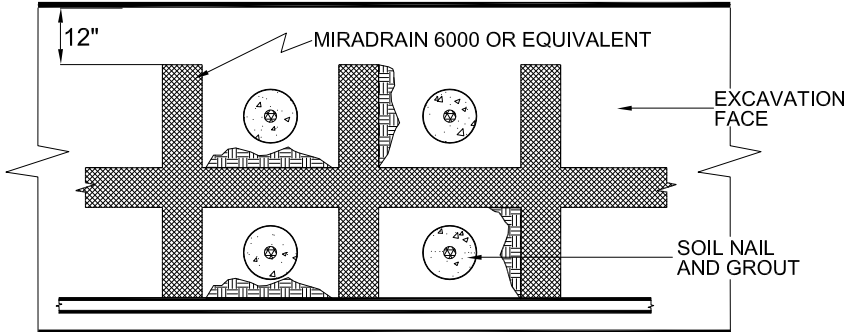
SOIL NAIL WALL DRAINAGE DETAIL

DRAINAGE PANELS PER SOIL NAIL WALL ENGINEER

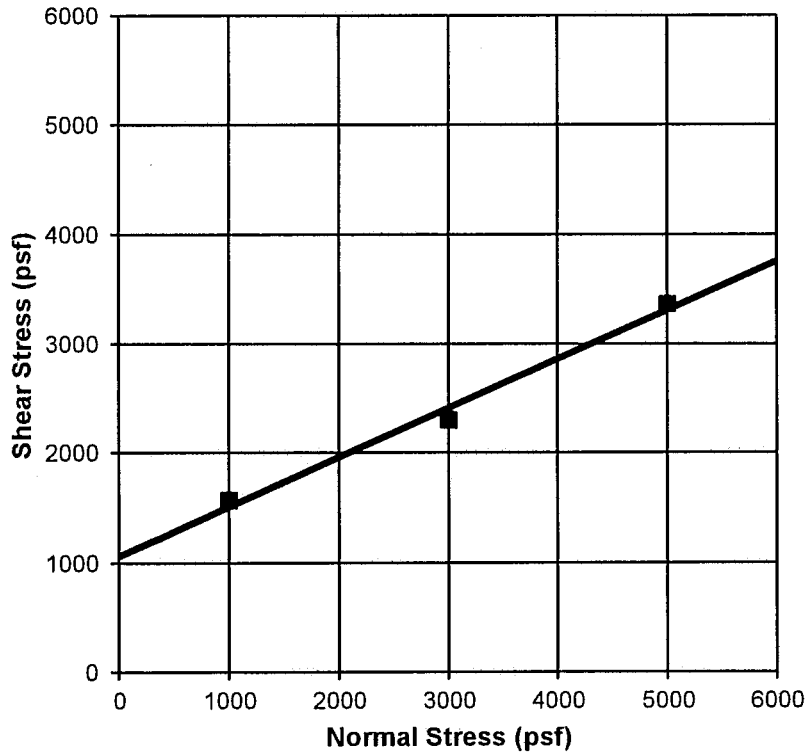
Test Data			
Load	1 K	3 K	5 K
<b>INITIAL</b>			
Water Content	43.1%	43.1%	43.1%
Dry Density (pcf)	74.0	74.0	74.0
Saturation*	92.5%	92.5%	92.5%
Height (inches)	1	1	1
<b>AFTER TEST</b>			
Water Content	48.3%	48.3%	48.3%
Dry Density (pcf)	74.0	74.0	74.0
<b>FAILURE</b>			
Normal Stress (psf)	1000	3000	5000
Shear Stress (psf)	1569	2302	3368
Rate (in/min)	0.01	0.01	0.01

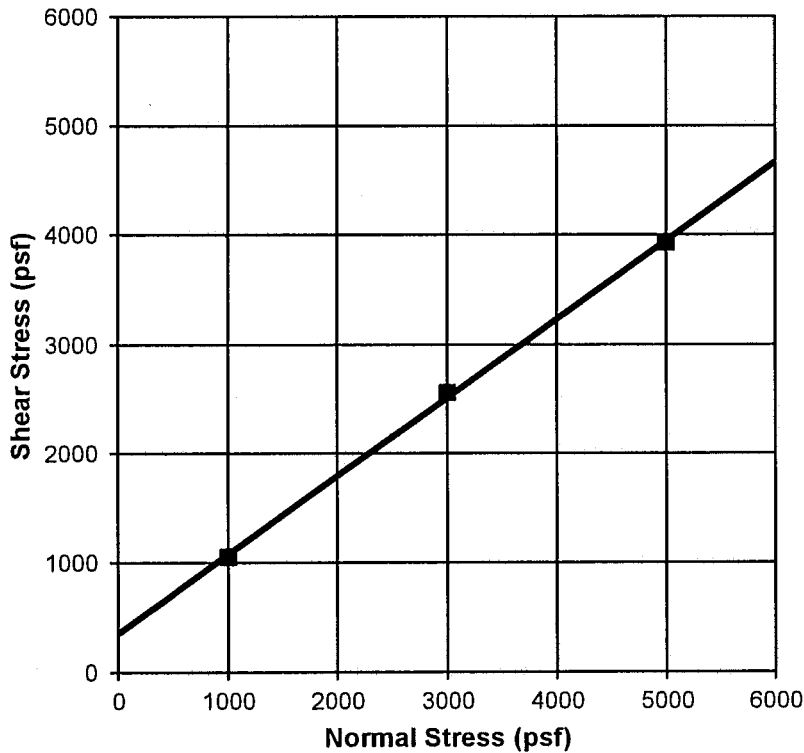
Test Data			
Load	1 K	3 K	5 K
<b>INITIAL</b>			
Water Content	27.8%	27.8%	27.8%
Dry Density (pcf)	74.6	74.6	74.6
Saturation*	60.5%	60.5%	60.5%
Height (inches)	1	1	1
<b>AFTER TEST</b>			
Water Content	52.2%	52.2%	52.2%
Dry Density (pcf)	71.2	71.2	71.2
<b>FAILURE</b>			
Normal Stress (psf)	1000	3000	5000
Shear Stress (psf)	1055	2563	3931
Rate (in/min)	0.01	0.01	0.01
